INSPECTION RELEASE NOTE/CERTIFICATE NO: IRN-Tecnix-RUNFENG-INA20210831-001 **DATE:** 31st Aug., 2021

INSPECTION REPORT

Inspection Report No:	IR-Tecnix-RUNFENG-INA20210730-001	Date:	10 th Aug., 2021
Inspection Notification No:	N/A	Date:	06 th Aug., 2021
PO No.:	INA20210730	Date:	30 th Jul., 2021
TUV India Control Or SAP Number:	8119512856		
Client:	Global Air Technix		
Material on Order:	Empty Cryogenic Cylinder DPL450-210-2.3 Design Code: GB 24159-2009		
Equipment Serial No:	DW210H-2111-020 & DW210H-2111-045 & DW210H-2111-044 & DW210H-2111-030 & DW210H-2111-015 & DW210H-2111-066 & DW210H-2111-022 & DW210H-2106-132 & DW210H-2106-120 & DW210H-2106-134 & DW210H-2111-024 & DW210H-2111-038 & DW210H-2111-050 & DW210H-2111-095 & DW210H-2111-096 & DW210H-2111-105 & DW210H-2111-071 & DW210H-2111-082 & DW210H-2111-085 & DW210H-2111-084 & DW210H-2111-083 & DW210H-2111-049 & DW210H-2111-086 & DW210H-2111-100 & DW210H-2111-099 & DW210H-2111-078 & DW210H-2111-043 & DW210H-2111-047 & DW210H-2111-042 & DW210H-2111-025 & DW210H-2111-040 & DW210H-2111-016 & DW210H-2018-017 & DW210H-2115-006 & DW210H-2111-054 & DW210H-2111-076 & DW210H-2111-061 & DW210H-2111-069 & DW210H-2111-089 & DW210H-2111-075

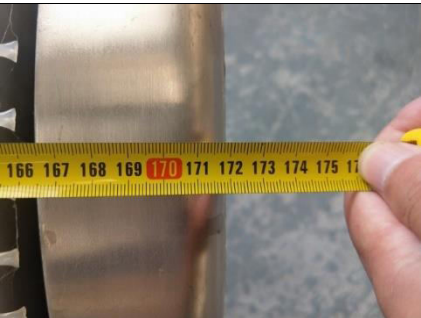
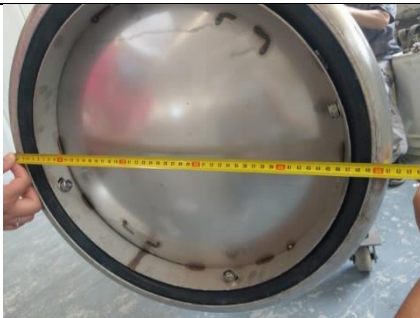
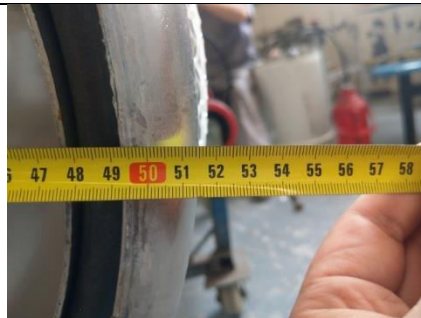
Pic.19 Checked the dimension	Pic.20 Checked the dimension	Pic.21 Checked the dimension

1. The factory provided a drawing without tolerance. The factory provided the tolerance, and the result was acceptable, Please refer to the Attachment 6 - Drawing.
- Reviewed the Calibration certificate of the steel type, the result was acceptable. Please refer to the Attachment 1 – Calibration certificate.
 - Randomly checked the dimension for 3pcs Empty Cryogenic Cylinder according to the emails with client, Drawing and Performa Invoice. Please refer to the below table and photos for details.

Dimension Inspection details				
No	OD /mm		Height /mm	
	Standard	Measurement	Standard	Measurement
1	516 ± 2	516	1717 ± 10	1720
2		515		1718
3		516		1721

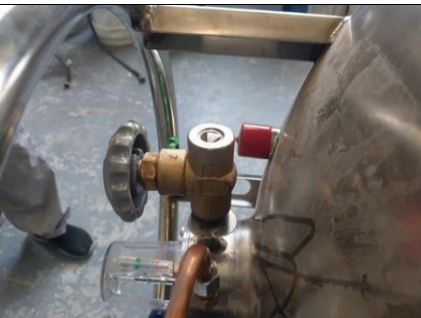
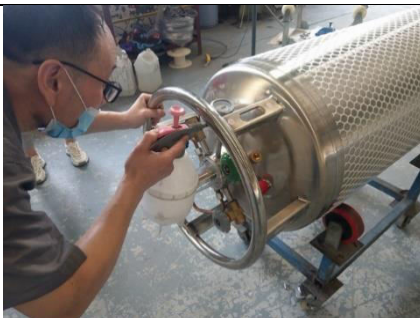
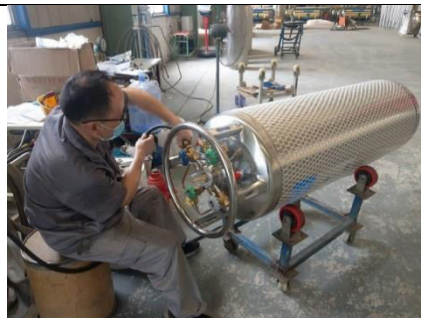
Pic.25 Witnessed the Pneumatic test	Pic.26 Witnessed the Pneumatic test	Pic.27 Witnessed the Pneumatic test

- Reviewed the Calibration certificate of the pressure gage, the result was acceptable. Please refer to the Attachment 1 – Calibration certificate.
- Randomly witnessed the Pneumatic test for 3pcs Empty Cryogenic Cylinder according to the emails with client, Performa Invoice and GB 24159, The test pressure was 2.3MPa for 3mins. Please refer to the following photos for details.
